Quartz Valley Indian Reservation

RE: 303 D Listing for Scott River Basin and tributaries

Comments requesting the State Water Resources Control Board to list the Scott River and Shackleford Creek as impaired by flow alteration

Comments requesting the State Water Resources Control Board to list the Scott River and Shackleford Creek as impaired by nutrients and bacteria

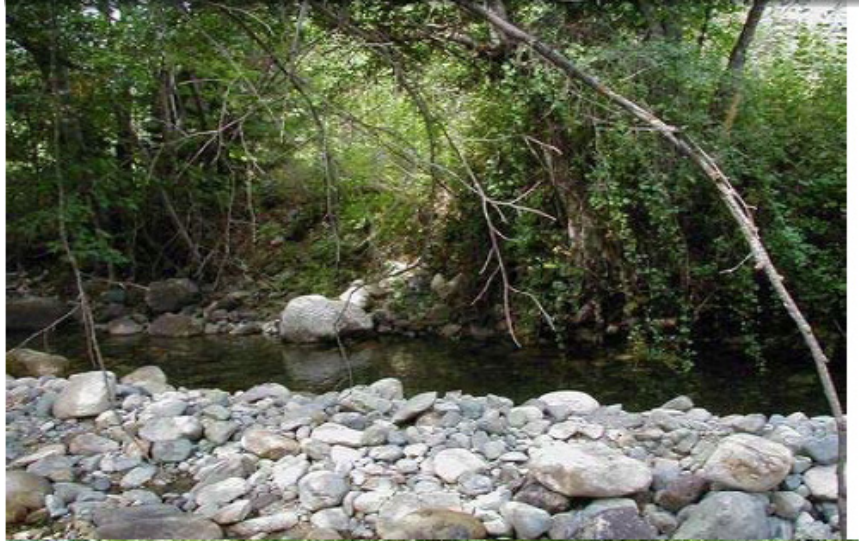
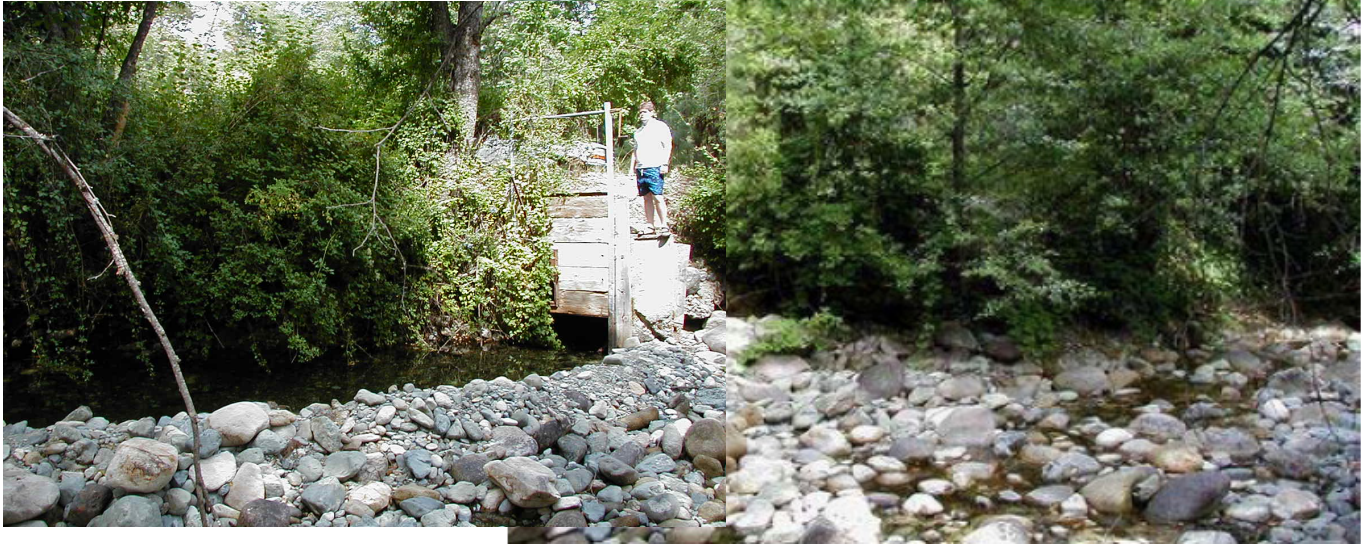
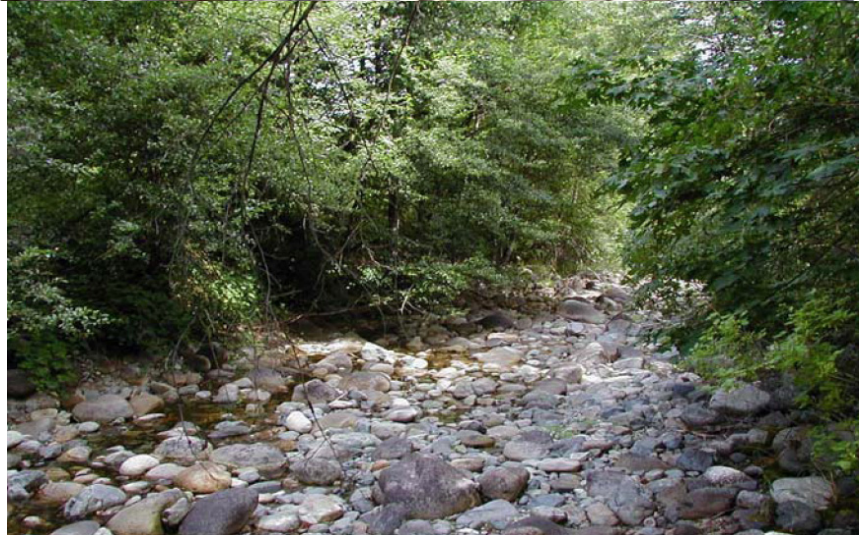
Figure 11. Jenner's diversion on Etna Creek: top photo—looking upstream of diversion, middle photos – at point of the diversion, and bottom photo – looking downstream of the diversion. August 2003. Lat/long coordinates: 41.43948, -122.89865. Photo by Bryan McFadin, NCRWQCB staff.

A single diversion on Etna Creek diverts almost the entire flow of creek (Figure 11).

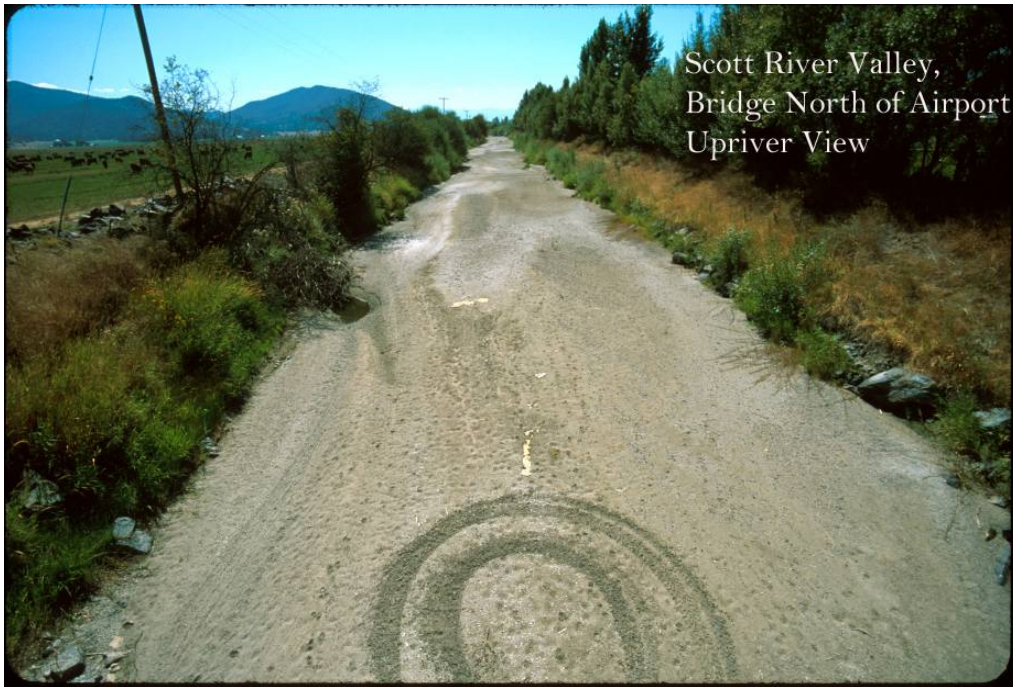
Figure 12. Summer 2002 photo of the dry Scott River bed looking off a bridge south of Fort Jones, not far north of the airport. Bridge is likely Island Road (lat/long coordinates: 41.57045, -122.84664). Photo by Michael Hentz, downloaded from KRIS (http://www.krisweb.com/krisklamathtrinity/krisdb/sc/scott_river_brnofairportup.jpg)

Available photographic evidence documents the drying up of the Scott River channel in 2002 (Figure 12), 2007 (Figure 13), and in 2009 across large stretches of the Scott Valley (Figures 14, 15, 16).

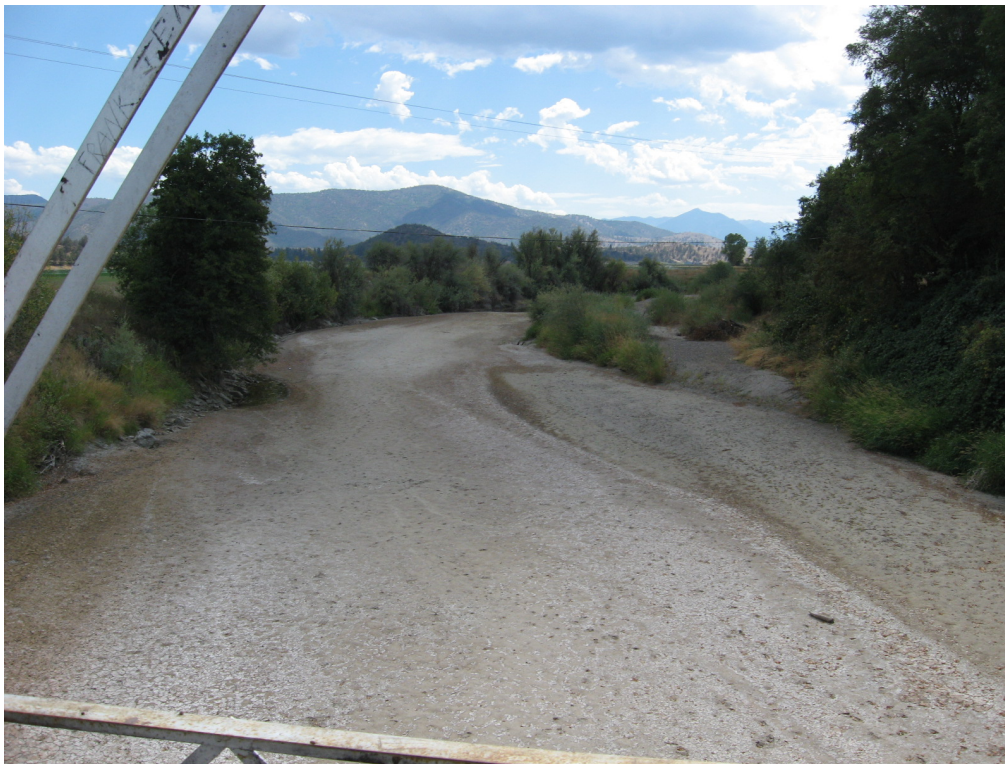
Figure 13. Photo of dry Scott River at Eller Lane, approximately halfway between Fort Jones and Etna. Lat/long coordinates: 41.51933, -122.8508. Photo by Bryan McFadin, NCRWQCB staff, August 30, 2007.

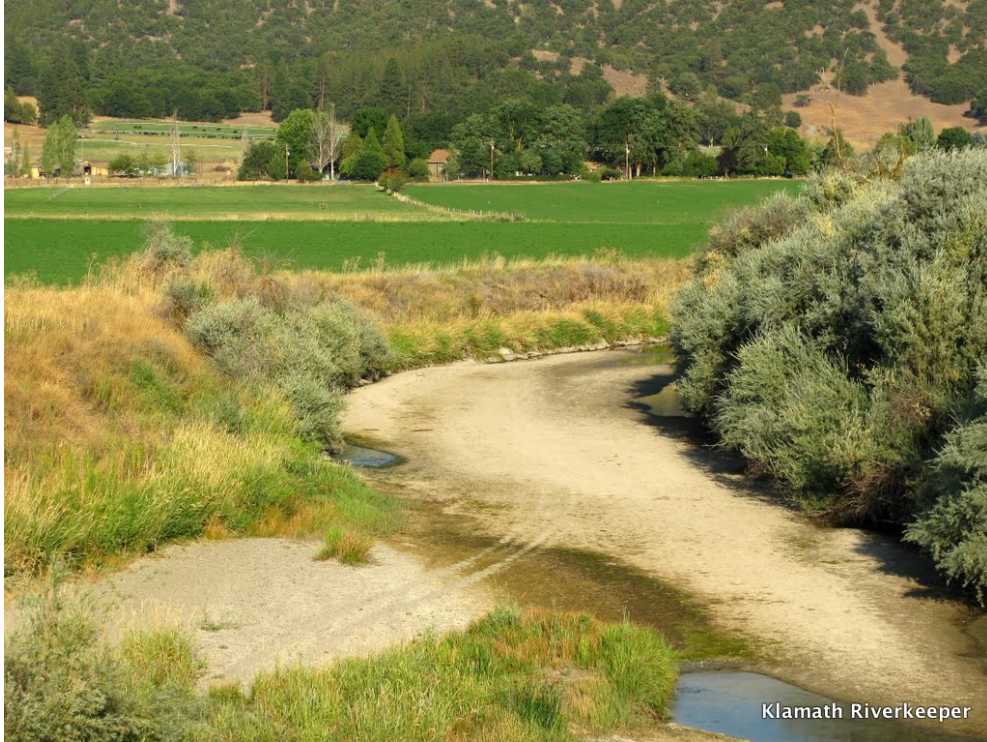
Figure 14. Mainstem Scott River at Highway 3 Bridge southwest of Fort Jones, August 23, 2009. Lat/long coordinates: 41.595474, -122.851547. Photo from Klamath Riverkeeper (<http://picasaweb.google.com/klamathriverkeeper/ScottAndShastaRivers2009FlowEmergency#5395238901042667954>)

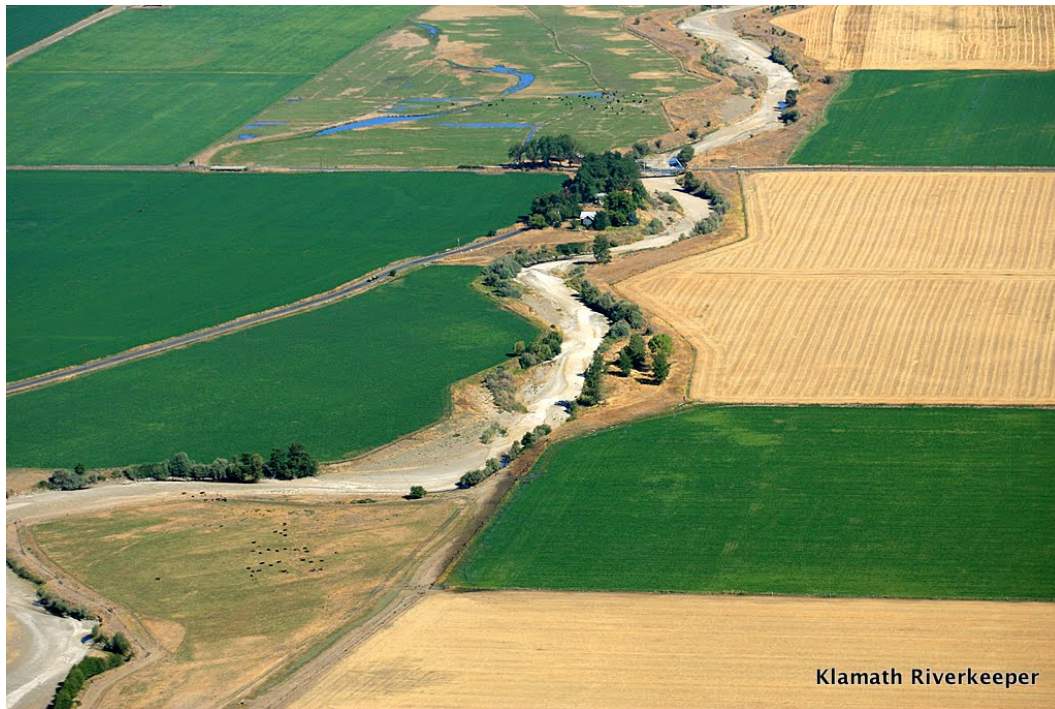
Figure 16. Dewatered Scott River, full irrigation ditches, and irrigated fields in central Scott Valley, Sept. 2, 2009. Lat/long coordinates: 41.496438, - 122.844658. Photo from Klamath Riverkeeper (<http://picasaweb.google.com/klamathriverkeeper/ScottAndShastaRivers2009FlowEmergency#5395238959214867394>).
